CASE STUDY: COARSE CRM ANALYSIS IDENTIFIES CRUSHER MALFUNCTION

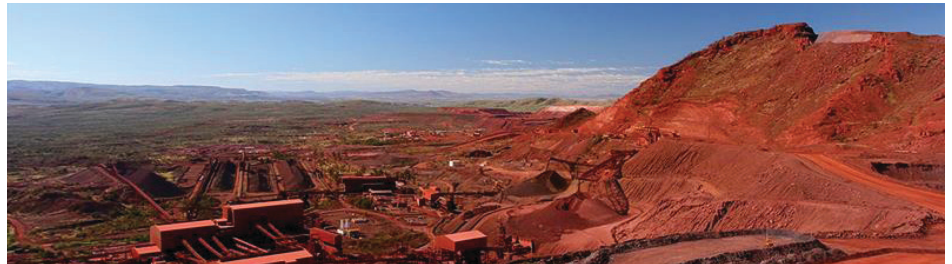
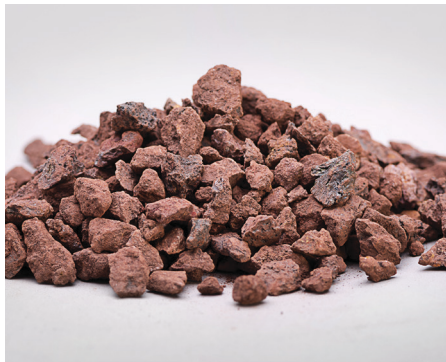
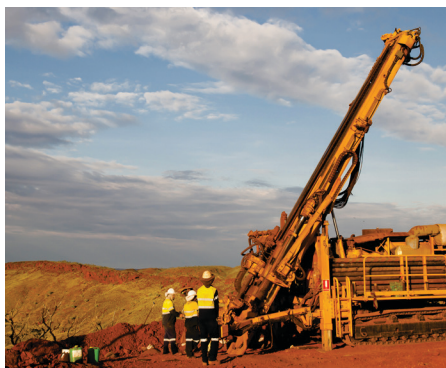
This laboratory operates three 'in-parallel' sample preparation trains. Each preparation train was monitored with coarse CRMs at regular intervals. Quality control (QC) data identified four samples (numbers 7, 10, 13 and 16), had failed with a high Fe reading - over three times the standard deviation of the expected value.

The same samples also failed at the low end for both SiO_2 and Al_2O_3 . A key property of the CRM was that the fines were known to contain elevated concentrations of both SiO_2 and Al_2O_3 compared to that of the entire sample.

Interrogation of the prep logs also showed that all the failed samples had passed through the same crusher (No 2).

The cause of the problem was identified as a damaged valve within the primary crusher. The damage was preventing the valve from fully closing whilst processing the sample. This caused loss of fines in the sample, that led to depression of SiO₂ and Al₂O₃ and elevation of Fe; thus, affecting the crusher's performance, and potentially biasing the analysis of routine samples.
